Finding of Necessity for the Kass Circle Neighborhood Revitalization Area

May 2015

Finding of Necessity for Kass Circle Neighborhood Revitalization Area

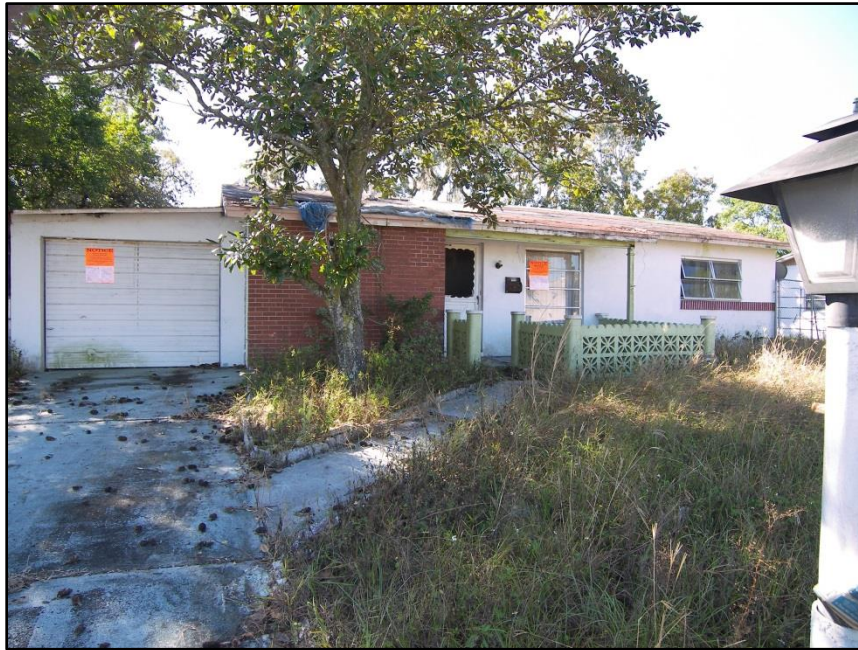
Figure 4. Examples of Residential and Commercial Structural Deterioration in the Kass Circle Area.

Deteriorated/unsafe structure with significant roof damage.

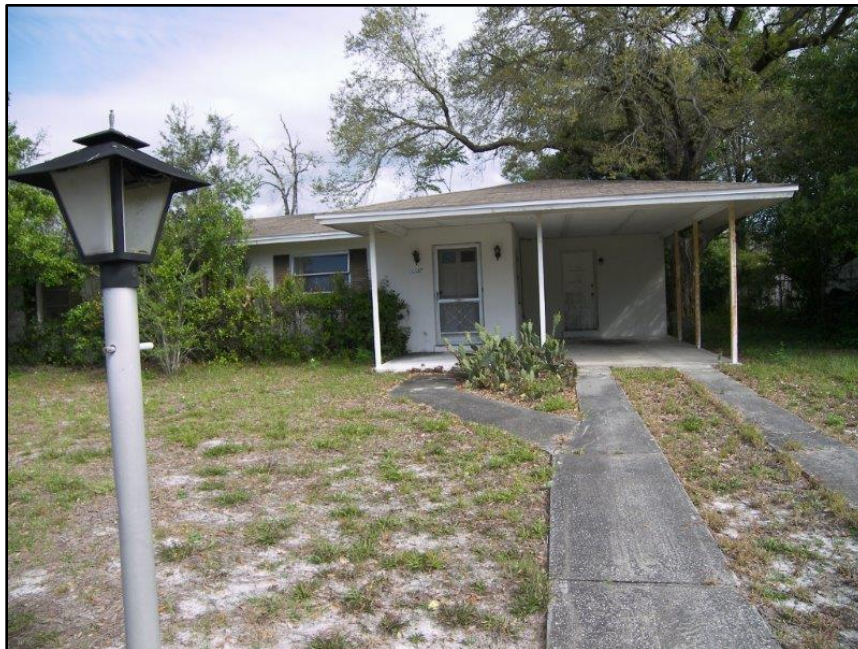
Signs of structural deterioration visible on doors and supports.

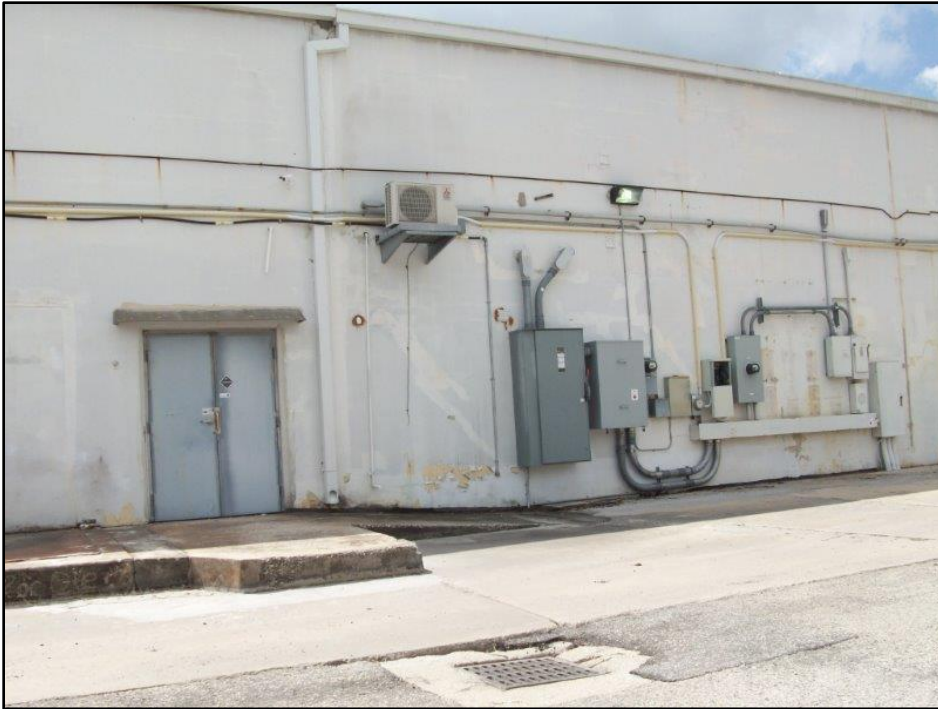
Figure 4. (continued)

Deteriorated commercial structure with abandoned and aging utility infrastructure.

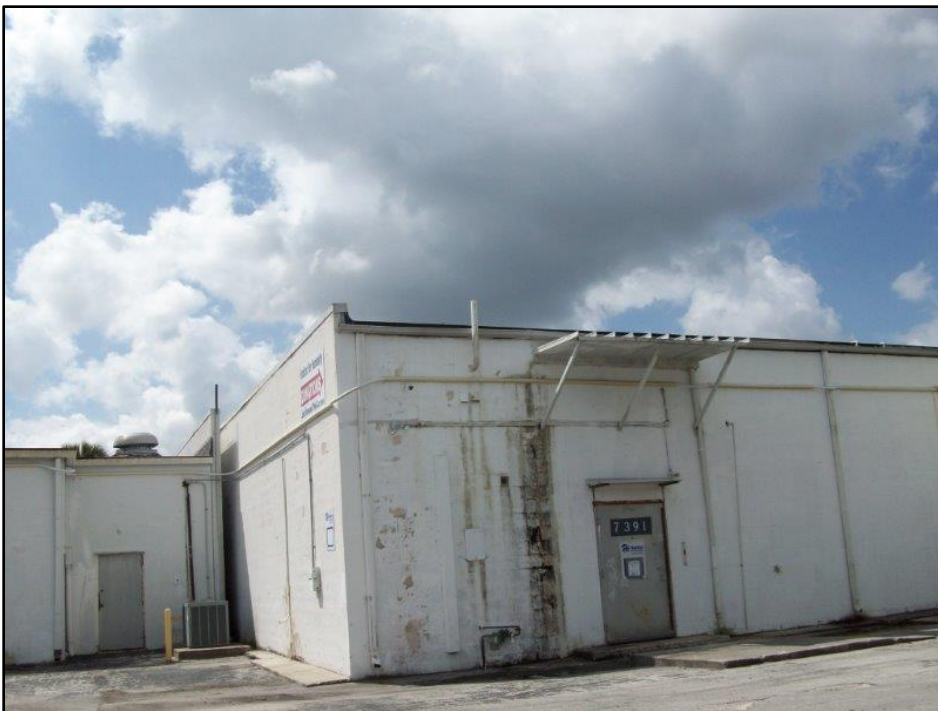
Deteriorated commercial structure with compromised external surface and aging utilities.

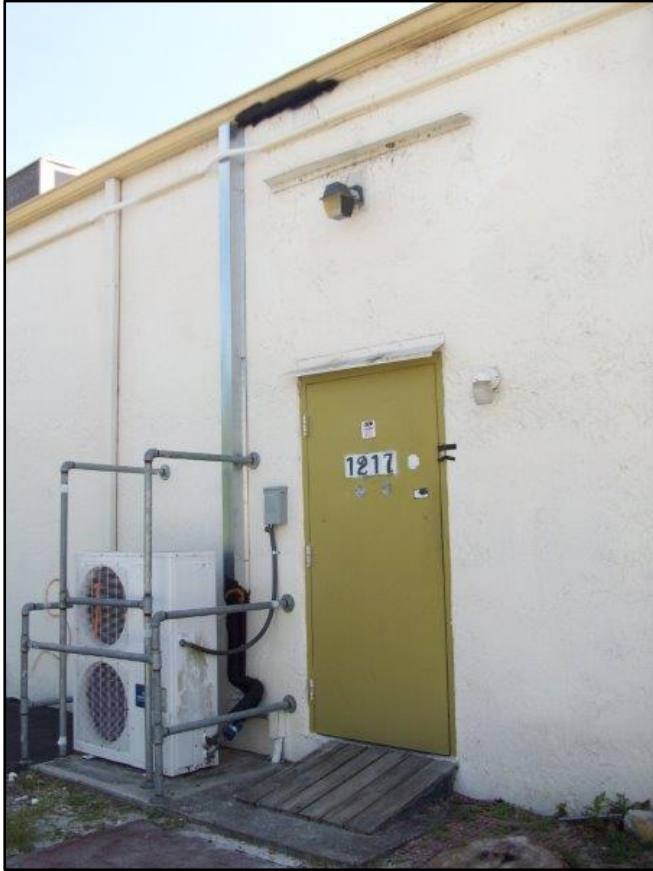
Figure 4. (continued)

Deteriorated commercial structure with mold-laden drainage and aging climate control system.

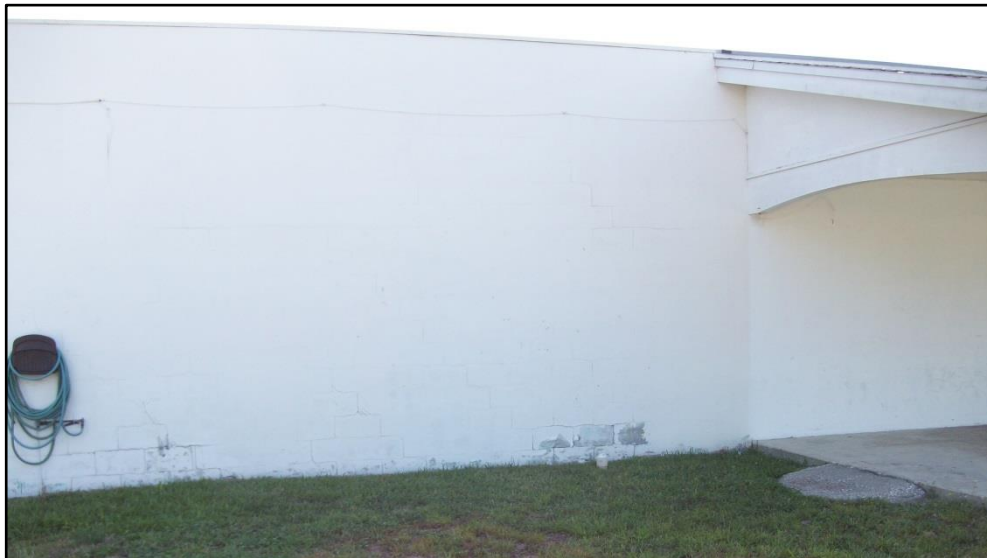
Deteriorated commercial structure with significant structural settling.

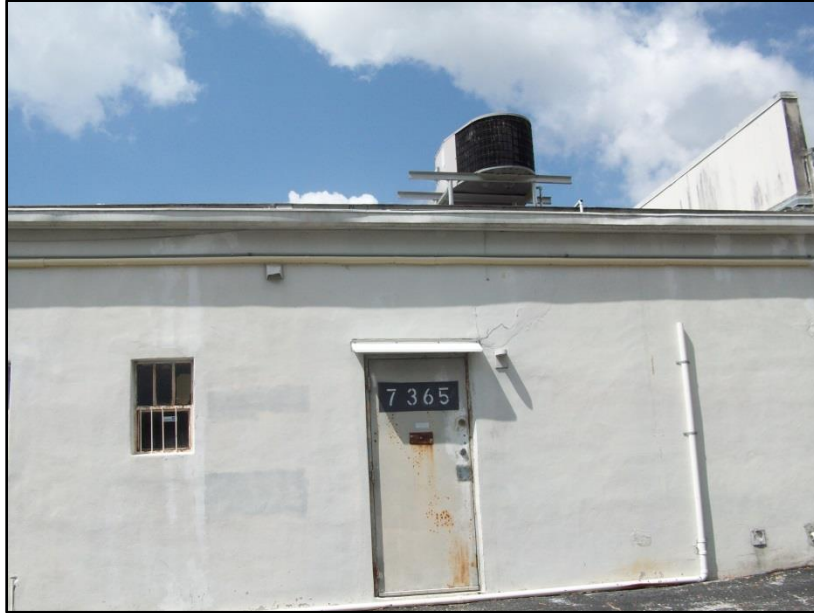
Figure 4. (continued)

Deteriorated commercial structure with significant deterioration visible on doors and windows, and, aging climate control system on roof.

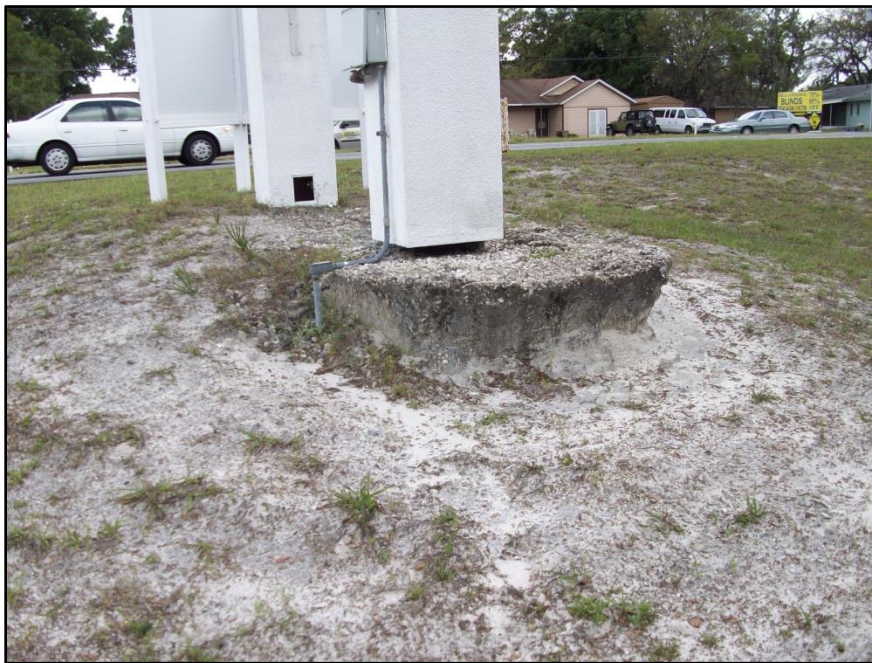
Large deteriorated and aging commercial sign structure with significant foundational compromise.

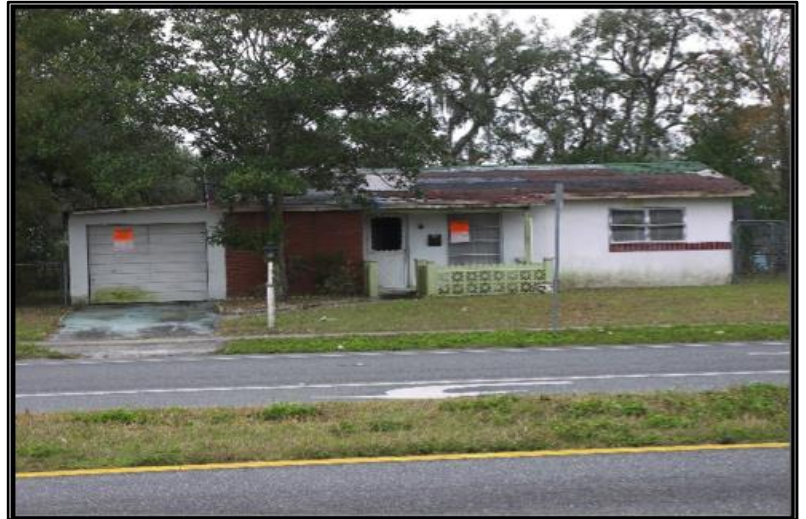
Figure 5: Abandoned Property

One abandoned property in the study area was condemned after being brought to the attention of County staff during the Kass Circle community meetings in Spring 2014. (Figure 5). That structure was demolished at County expense in April 2015. In general, many residential and commercial properties throughout the area show signs of aging and lack major upgrades.

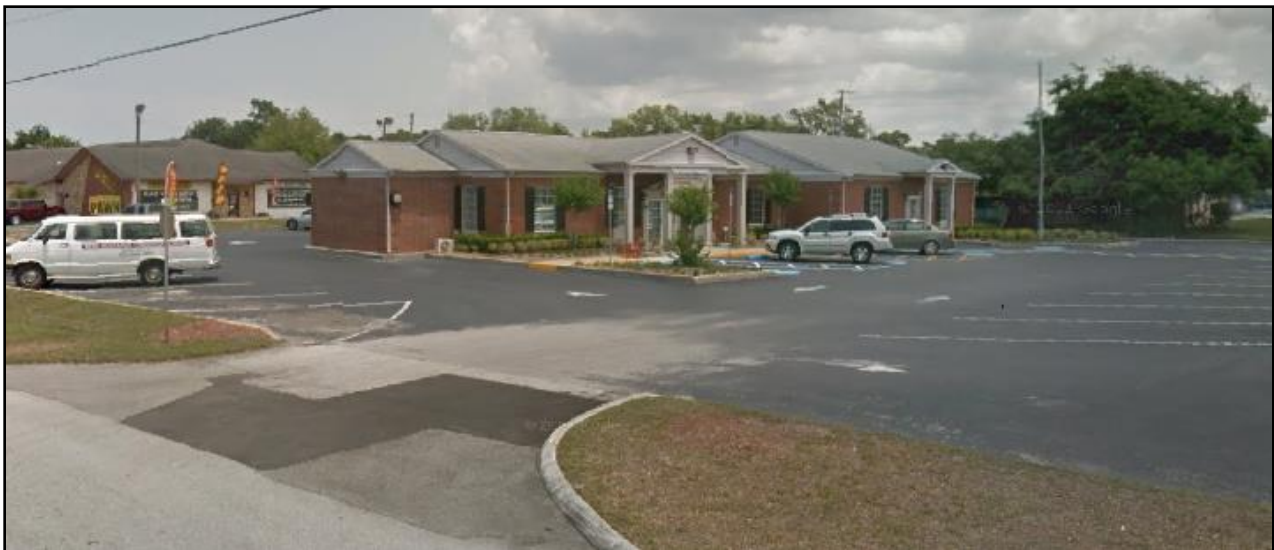
Figure 8: Fragmented Pavement Repairs

While a few newer businesses have good or excellent parking facilities, they stand in stark contrast to the aging parking of the commercial center and other businesses along Kass Circle and Spring Hill Drive. The aging parking facilities are in need of resurfacing. However, patchwork repairs are evident in some parking lots, which lend a discontinuous character to the parking facilities along Spring Hill Drive and Kass Circle, as shown in Figure 8. Overall, much of the parking areas are in disrepair and show a general lack of investment. Further details about the condition of parking and drives can be found under Site Deterioration on page 55.

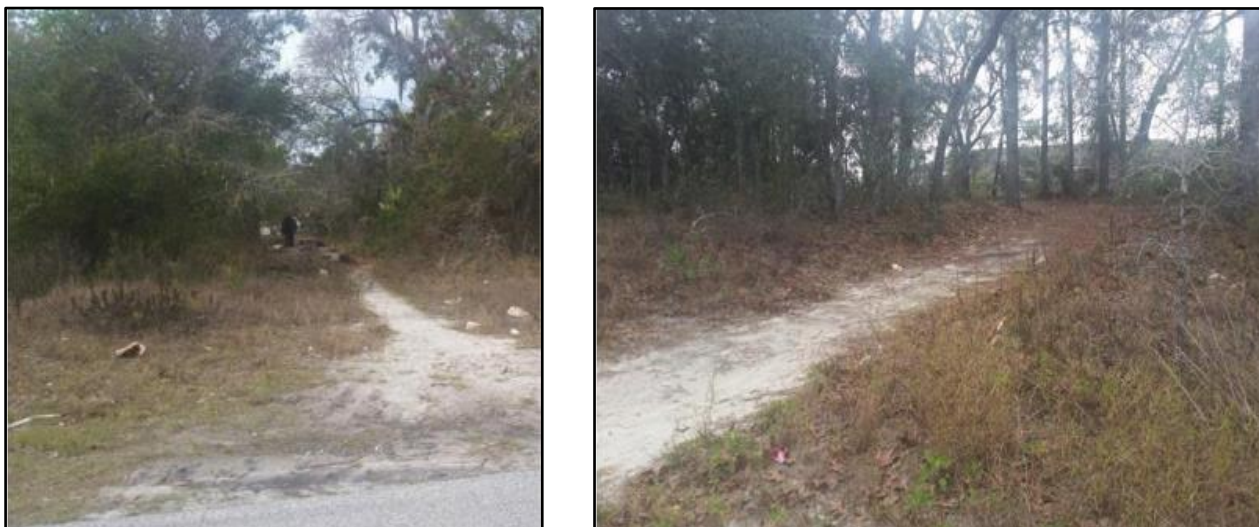
Figure 15: Informal Pathways in Study Area

There are no sidewalks in Kass Circle's multi-family neighborhood and no dedicated pedestrian connections from there to the Commercial Center. There are also poor sidewalk linkages between different parts of the Commercial Center. As a result of this lack of connectivity, plaza patrons have created informal paths through wooded areas and vacant private properties to access the businesses in the plaza (Figure 15).

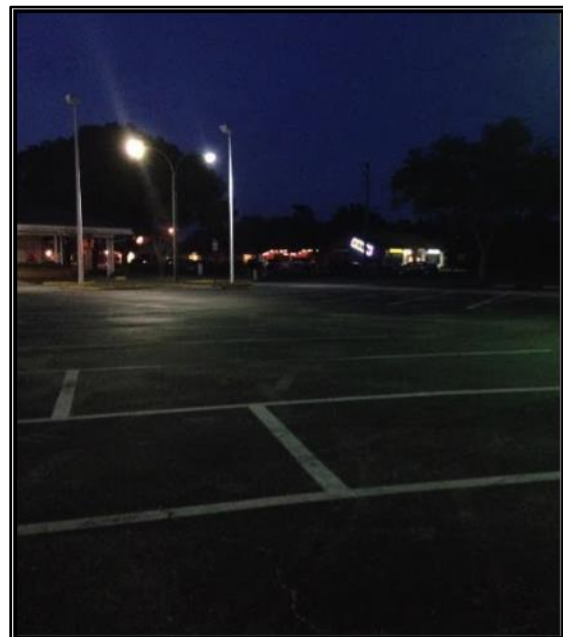
Figure 25: Inadequate Lighting

The Spring Hill Plaza parking lot and surrounding area, including entrances along Pinehurst Drive and Spring Hill Drive, is particularly dangerous to pedestrians and bicyclists at night. The light that is utilized by the parking lot is from store-front marquees, as shown in Figure 25. The parking lot and off-street entrances are poorly lit, making it difficult for drivers to see individuals trying to cross the street or access the stores within Kass Circle.

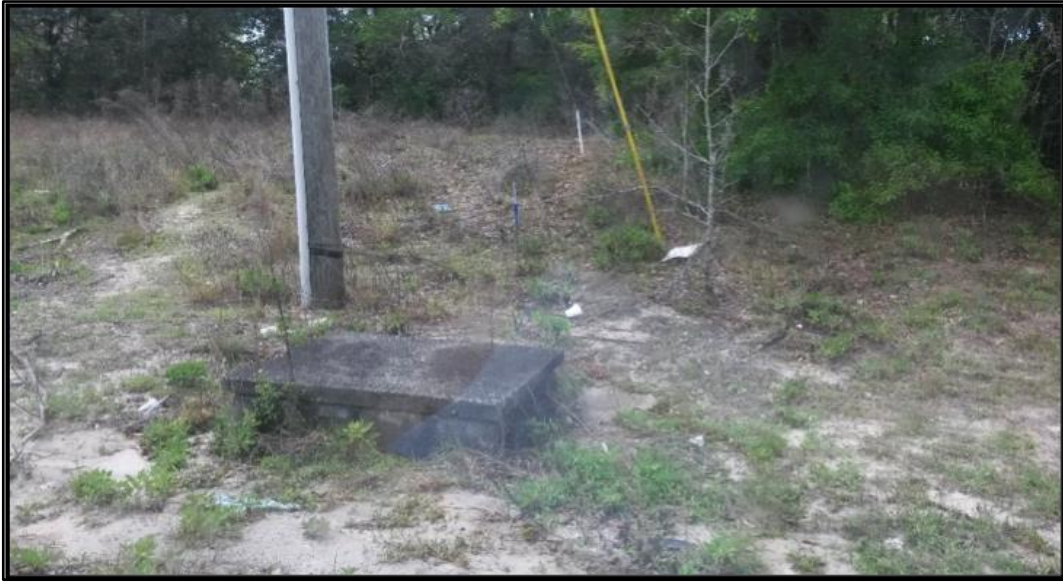
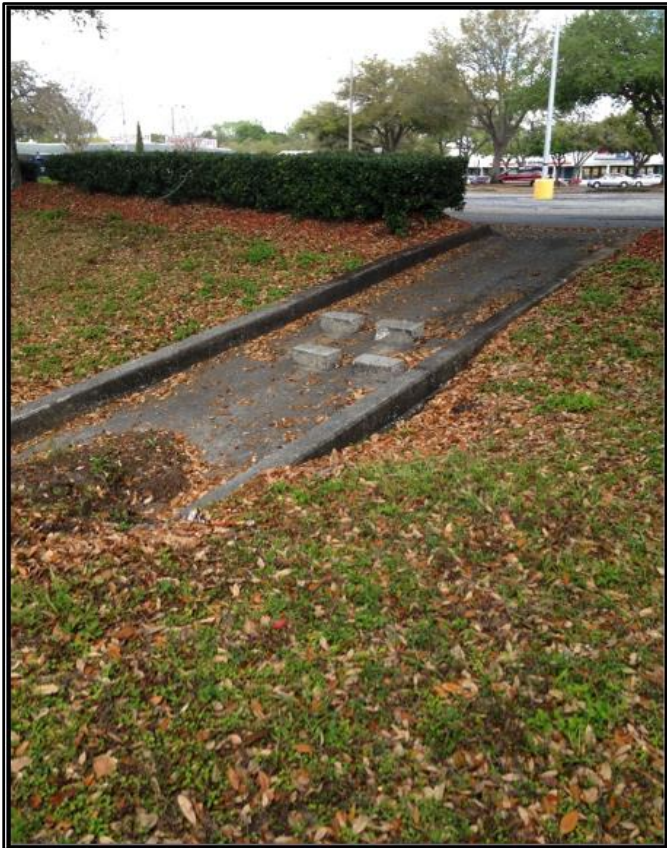
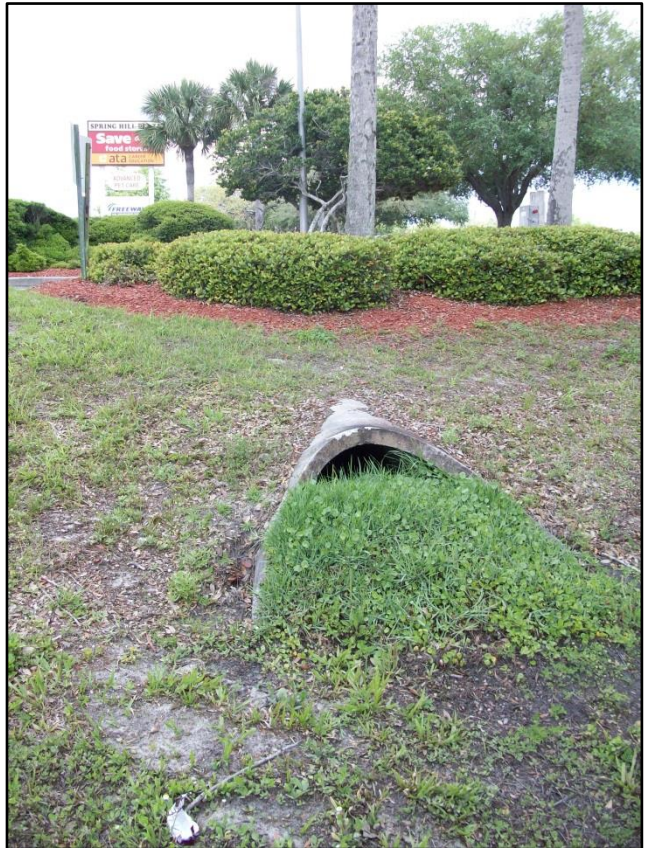
Figure 27: Unsafe and Inadequate Drainage Facilities

Kass Circle is not located within a high-risk flood zone. According to data from the Federal Emergency Management Agency, the chance of a flood occurring within 100 years is minimal. However, there are potentially hazardous conditions in the area related to inadequate stormwater facilities. The images in Figures 26 and 27 illustrate the location and condition of the current storm water drainage systems. The existing storm drains and run-off areas are blocked by debris and not properly maintained. The area may be at risk from flooding during heavy rain due to inadequate stormwater handling capacity. This is evident in blocked culverts and erosion patterns where water has been diverted. Storm drains and culverts are designed differently throughout the study area, and many are under construction, not property secured, or not properly marked, presenting unsafe walking conditions for pedestrians.

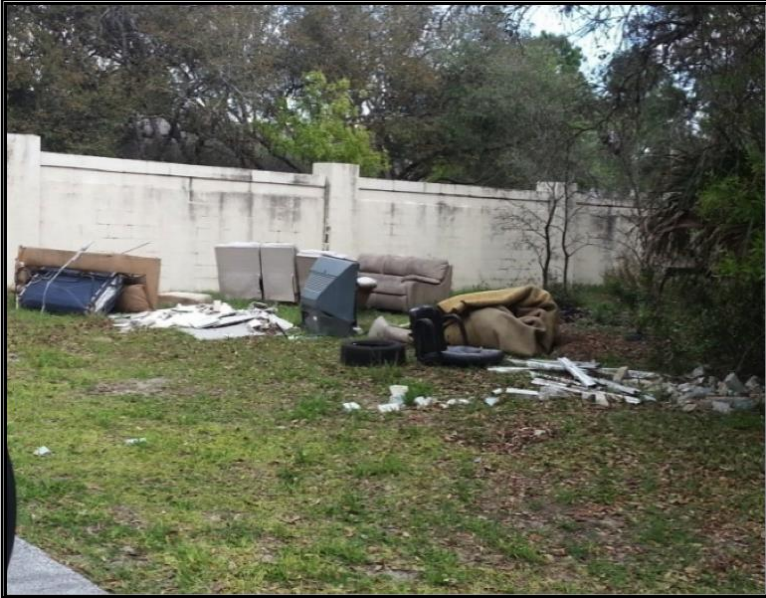
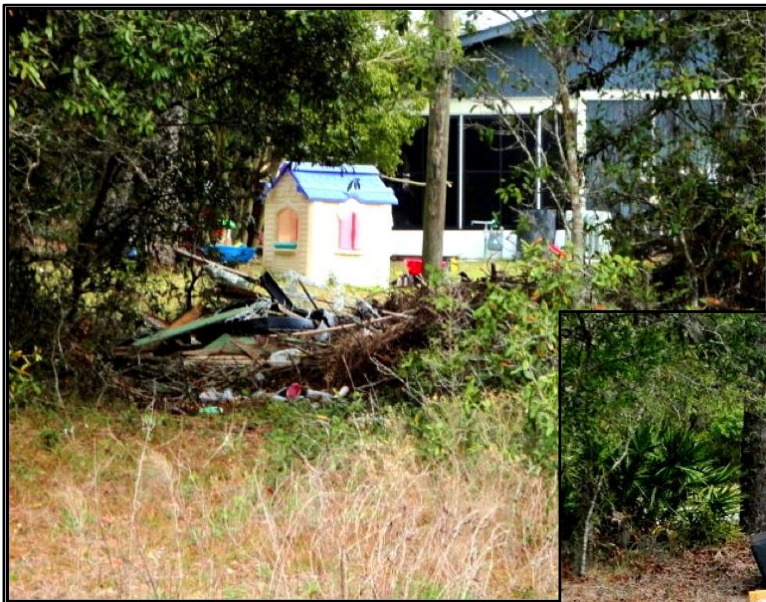
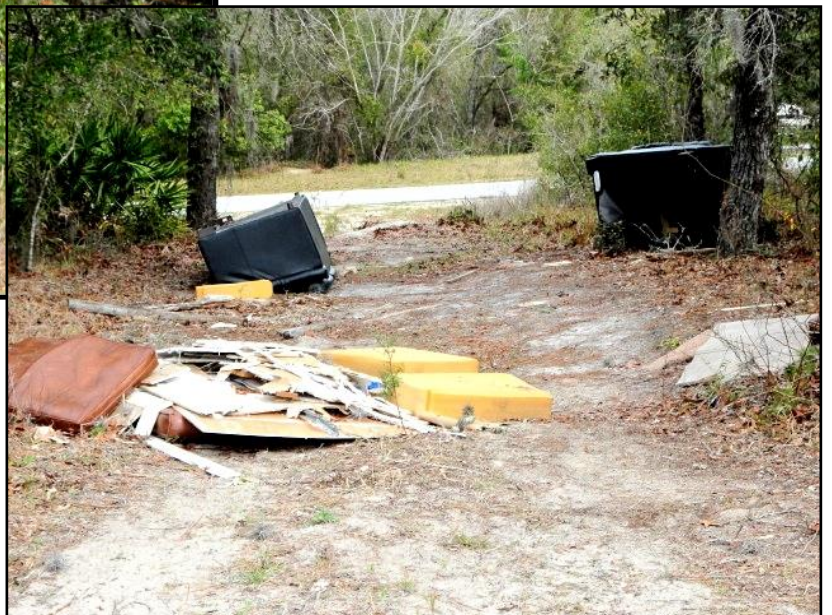
Figure 30: Illegal Dumping and Informal Pathways in Wooded Area

The wooded areas create extremely unsafe conditions for several reasons. There is an abundance of debris including large items such as couches and televisions (Figure 30). Several informal pathways traverse these areas between the plaza and neighborhoods, but no lighting or demarcated paths are available. Some of the vacant properties have been used as encampments by the homeless (Figure 31). Although the Sheriff's office regularly assists homeless residents in locating appropriate services, this has been a chronic problem over the years. The area is highly unsafe and unsanitary, and seriously impacts the economic viability and livability of the area.

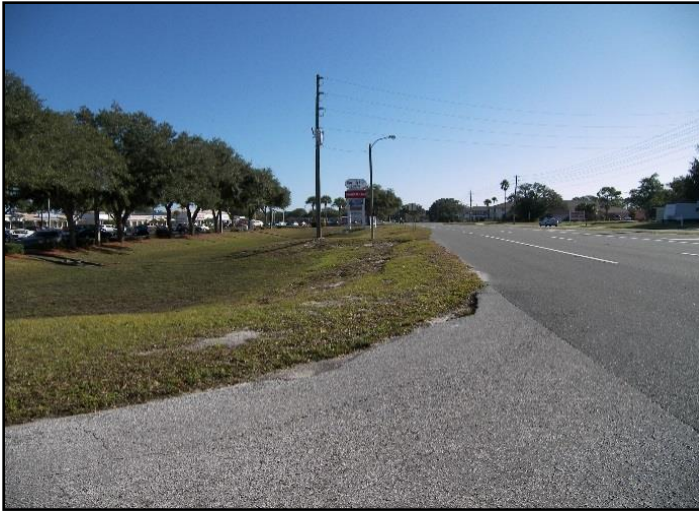
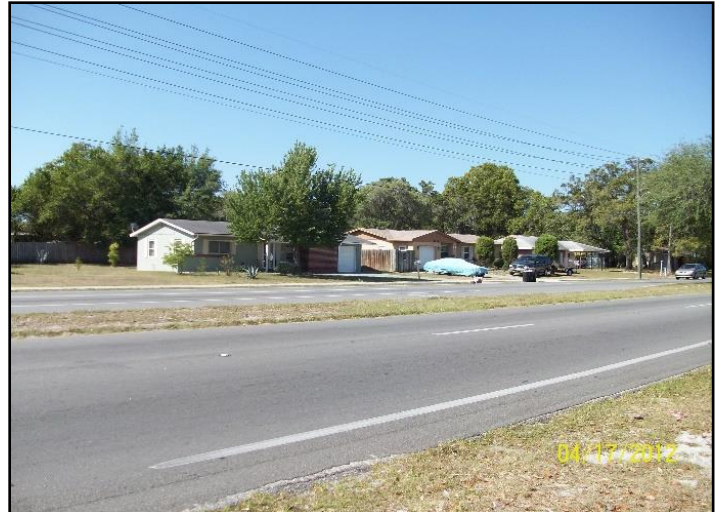
Figure 34: Inadequate Landscaping

The lack of landscaping also contributes to the deteriorated aspects of the Kass Circle project as a whole. Roadways are especially devoid of any landscape design. Drainage ditches are very visible adjacent to numerous intersections.

Roadways devoid of any landscaping (Spring Hill Drive).

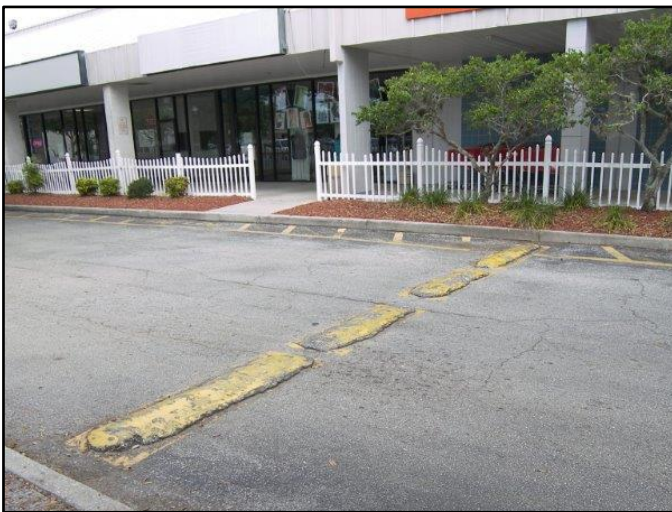
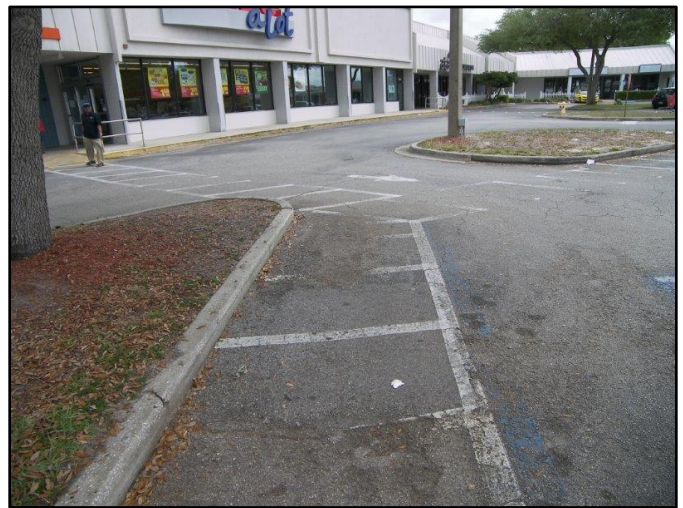
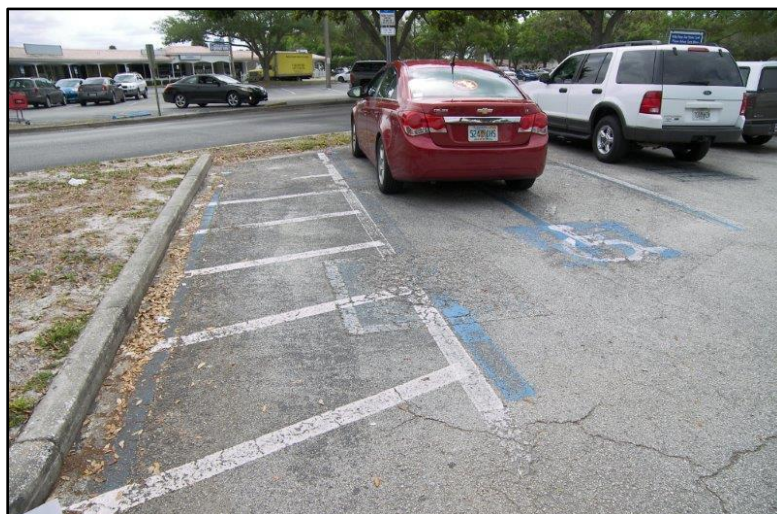
Figure 35. Deteriorating speed humps, pedestrian crossings and disabled parking.

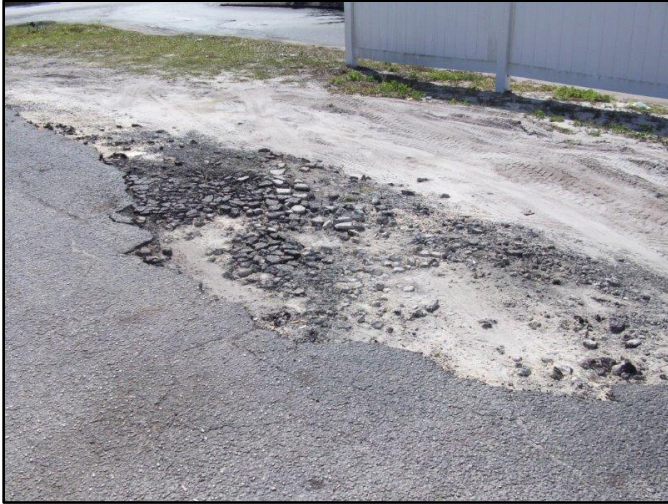
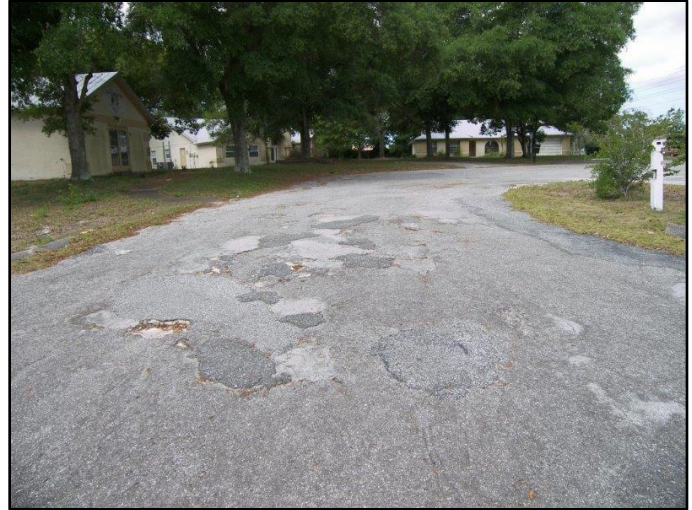
Figure 36. Deteriorating curbs and pavement conditions
