HERNANDO COUNTY BUS STOP ADA ASSESSMENT FINAL REPORT

February 25, 2014

Prepared For:
Hernando County MPO
20 North Main St
Brooksville, Florida 34601

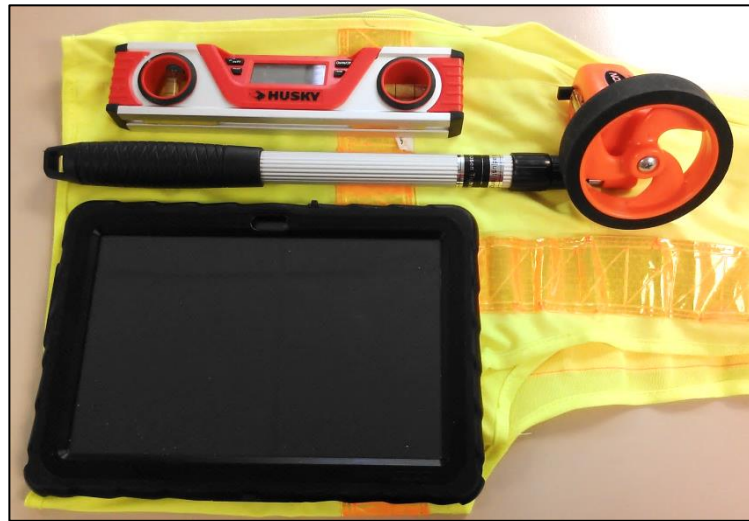
Figure 2-1 Data Collection Tools

Figure 2-1 illustrates the primary equipment utilized by the surveyor teams during the data collection process.

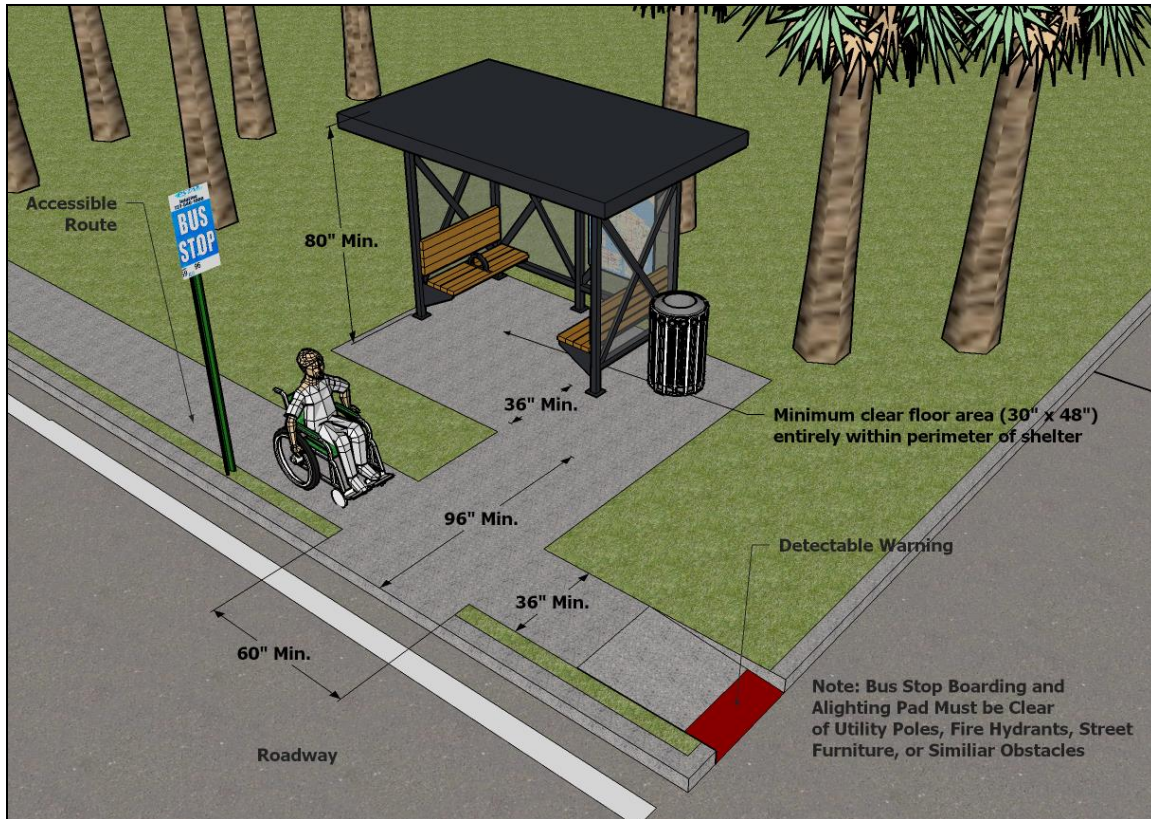
Figure 3-1 General Bus Stop Accessibility Standards Diagram

- If a shelter is provided, it must connect to the accessible route and allow a minimum space of 30" X 48" fully within the shelter.
- If a bench is included within a shelter, it must allow a minimum space of 30" X 48" resting/transfer space at one end of the bench.

Figure 3-1 illustrates a number of these general accessibility requirements.

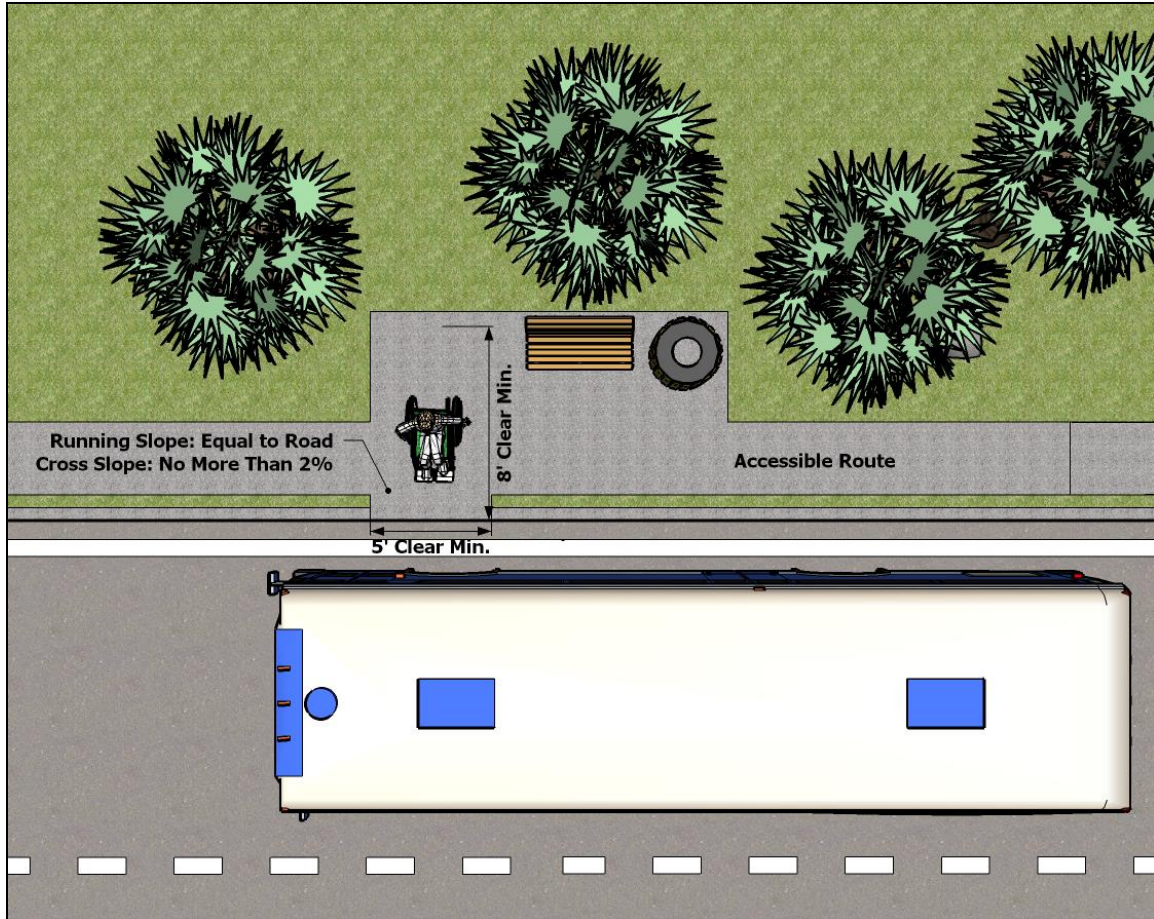
Figure 3-2 Landing Area Standards Diagram

- The clear area of the boarding and alighting area must be no less than 60” parallel and 96” perpendicular to the curb or street/roadway edge and connected to the accessible route.
- The cross slope of the boarding and alighting area (perpendicular to the curb) must be equal to or less than 2 percent.
- The running slope (parallel to the curb) of the boarding and alighting area should match the slope of roadway.
- The boarding and alighting area must provide a firm, stable, slip resistant surface.

Figure 3-2 illustrates some of these standards.
