Finding of Necessity for the Kass Circle Neighborhood Revitalization Area

May 2015

Finding of Necessity for Kass Circle Neighborhood Revitalization Area

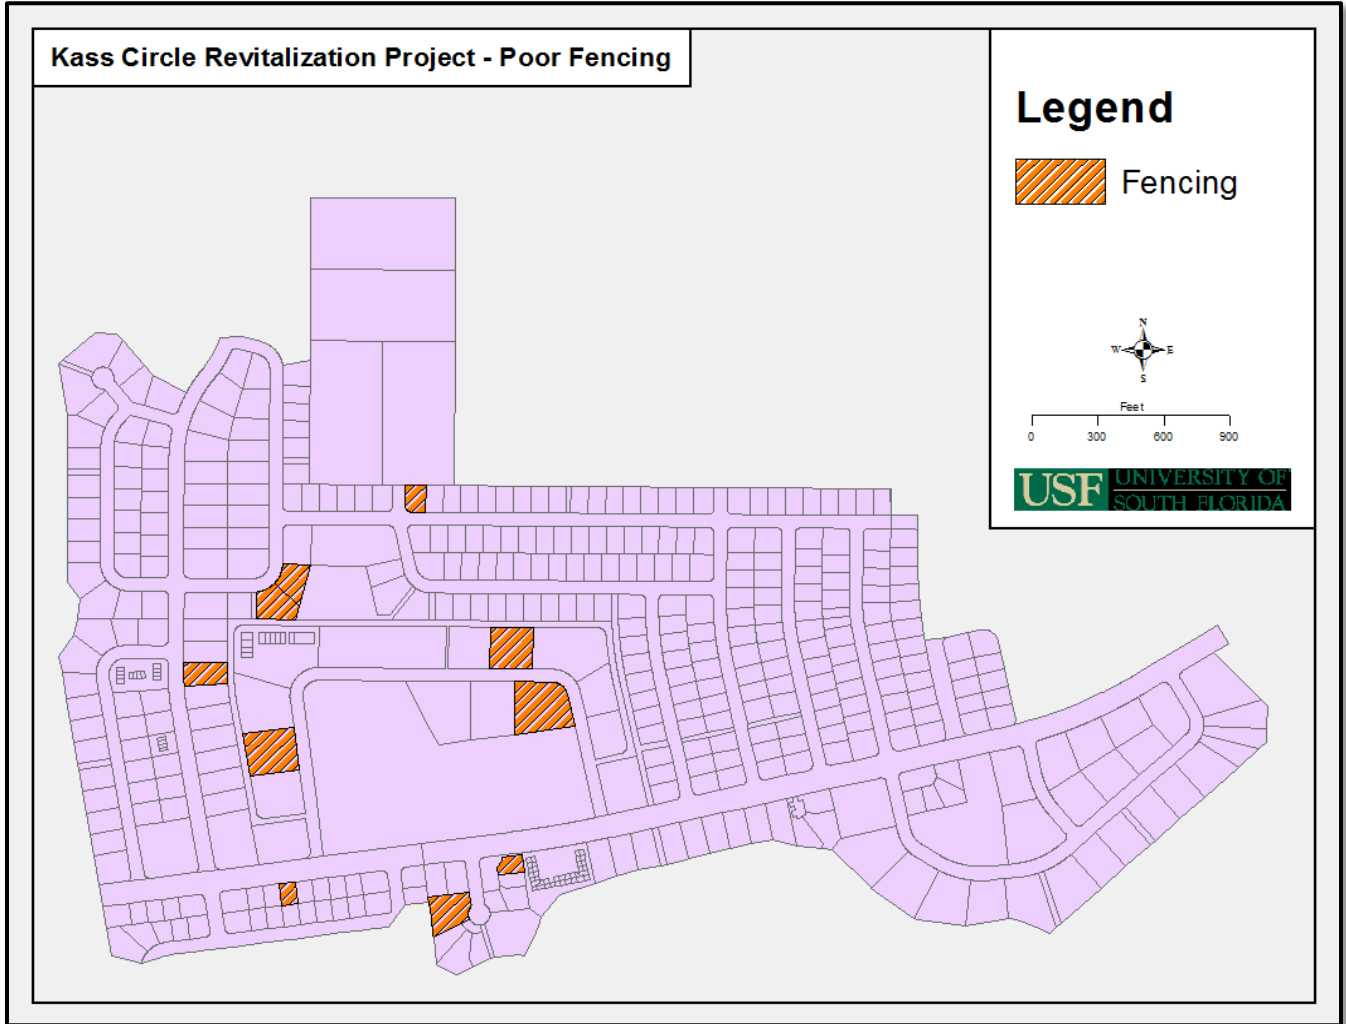
Figure 32: Map of Poor Fencing

The condition of existing fencing can help determine the degree of blight and site deterioration in an area. If unmaintained, it can create an unsafe as well as unappealing environment. On residential properties in the study area, there was a large amount of both wood and chain-link fences which detracted from any aesthetic cohesion. Many fences were in disrepair.

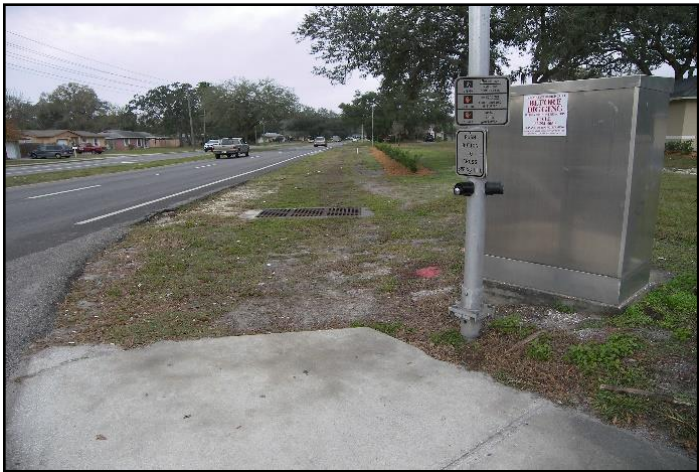
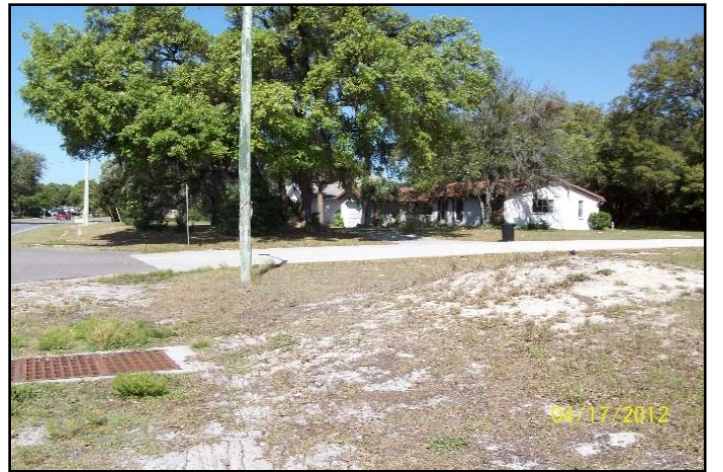
Figure 34: Inadequate Landscaping

The lack of landscaping also contributes to the deteriorated aspects of the Kass Circle project as a whole. Roadways are especially devoid of any landscape design. Drainage ditches are very visible adjacent to numerous intersections.

Without landscaping, drainage areas became the dominant feature at residential street corners.

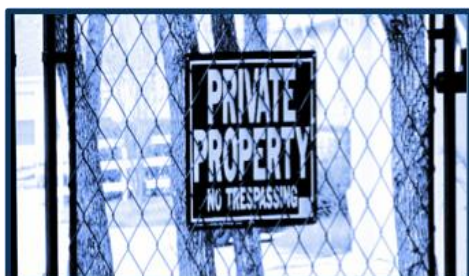
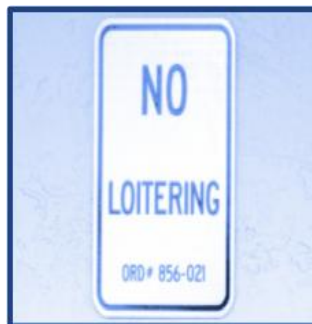
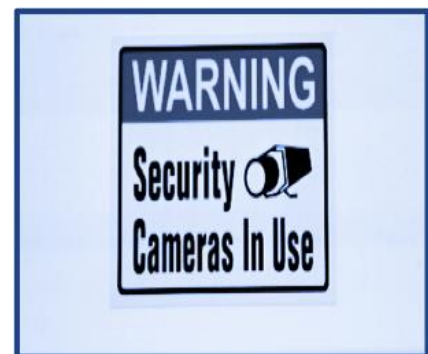
Figure 37: Crime Related Signage in the Study Area

The percentage of crime in an area can be a strong indicator of deteriorating conditions. Deteriorating conditions that are left unaddressed can contribute to escalating incidences of crime, and therefore discourage growth and development in the area. To analyze this blight factor, data from Hernando County and the U.S. Census were used to compare per capita crime incident calls for the Kass Circle area and Hernando County. The study team also identified several images of signage that suggest that the community is on guard against crime, as shown in Figure 37. Based on this analysis, it was observed that this blight factor was present within the Kass Circle study area.

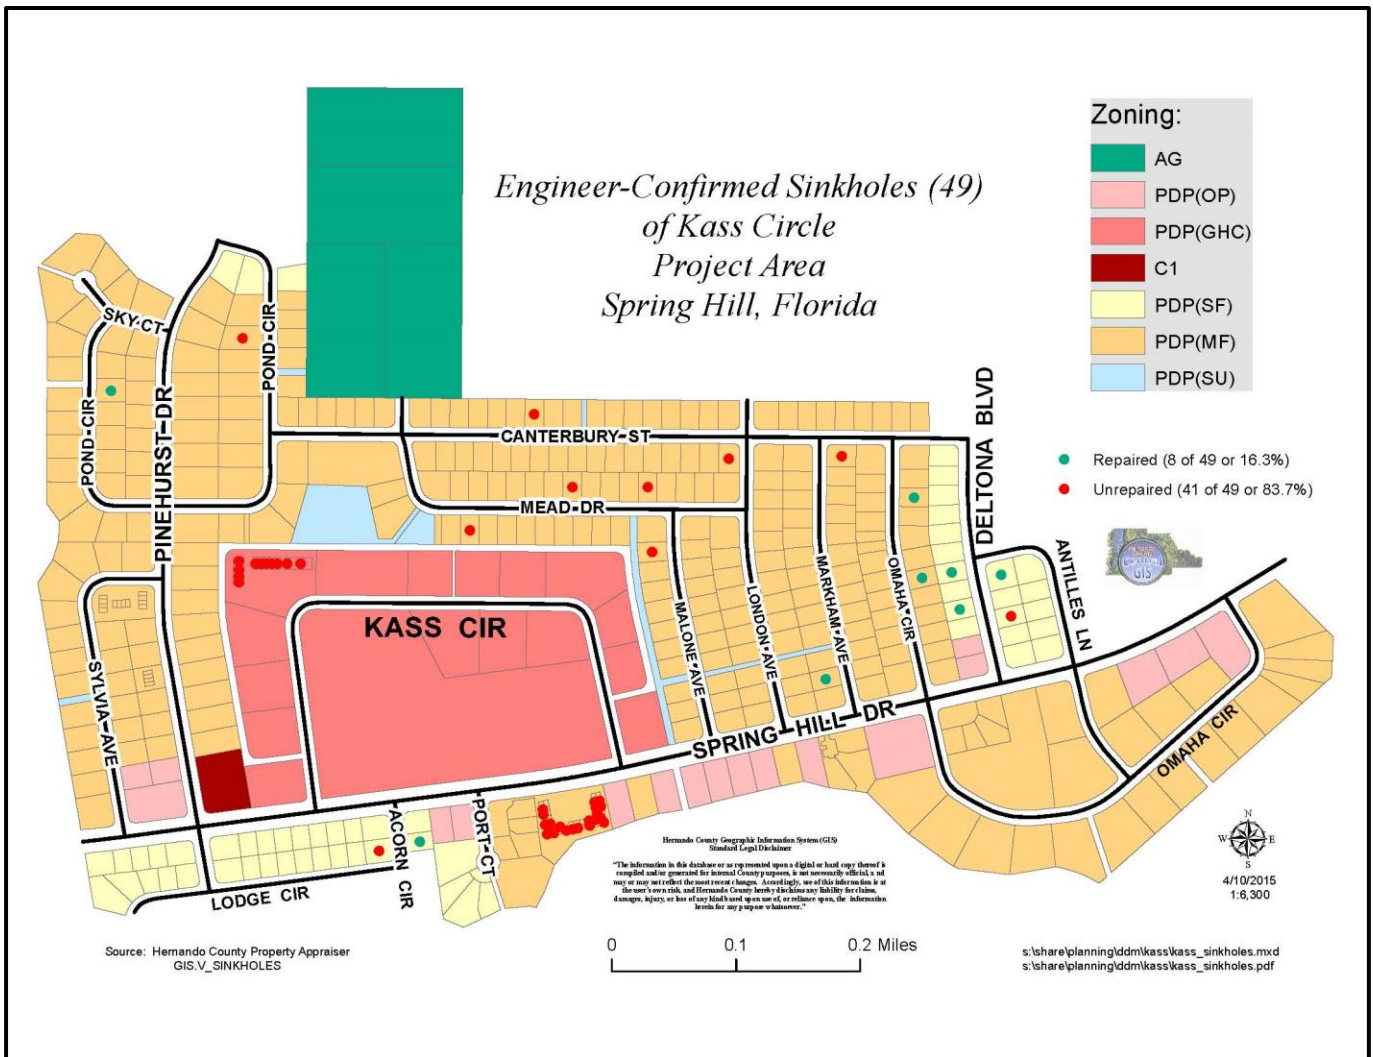
Figure 41. Engineer-Confirmed Sinkholes in Kass Circle Study Area showing Repaired (green dot) and Unrepaired (red dot) Damage

The Kass Circle area currently has 49 engineer-confirmed sinkhole reports filed on properties with existing structures. Figure 41 shows the locations of repaired and unrepaired sinkhole damage. Eight of these have been repaired leaving nearly 84% (41) unrepaired sinkhole incidents. Even accounting for multi-family properties, sinkholes on only 7 of 20 properties (counting condominium buildings as one property) have been repaired, still leaving 65% of the properties unrepaired.
